## Middle Latitude Cirrus Cloud Properties Experiment (MACPEX) Flight 1 Summary Report (1 April 2011).

### 2. Flight Summary

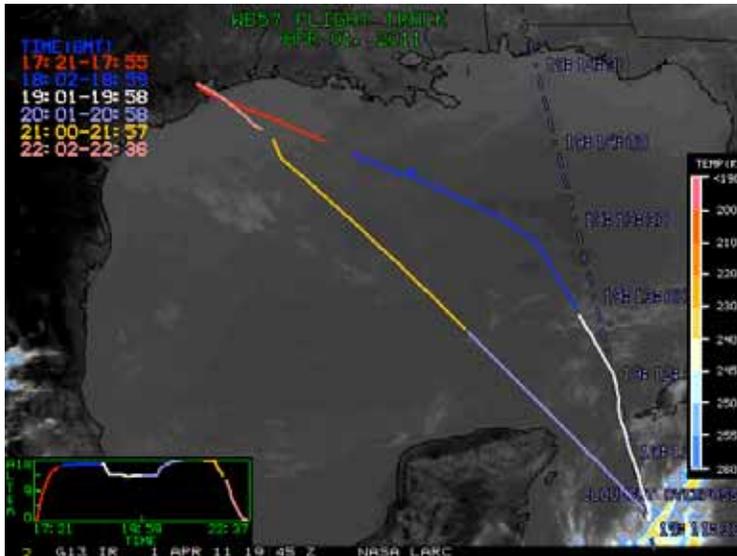
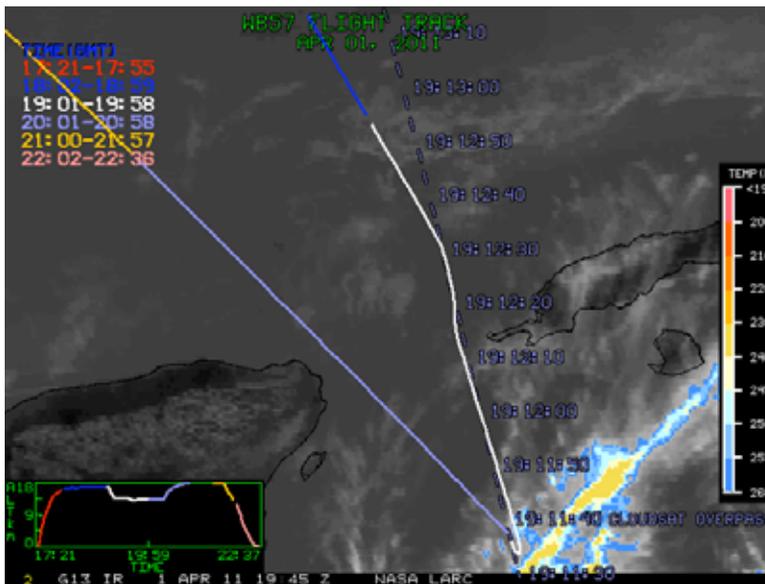
Figure 1. Flight Track overlaid on IR satellite image. Dashed line is Cloudsat track. Images Courtesy of Minnis Group.

The aircraft launched at approximately 16:30 UTC and encountered the Cloudsat track at approximately 19:15 UTC. Thin Cirrus were found at flight level 410. The track was flown southbound in cirrus for approximately 50 nautical miles with the sampling of this region again during the northbound leg of the flight. A cruise climb to max altitude (~57 Kft) was conducted on the return.

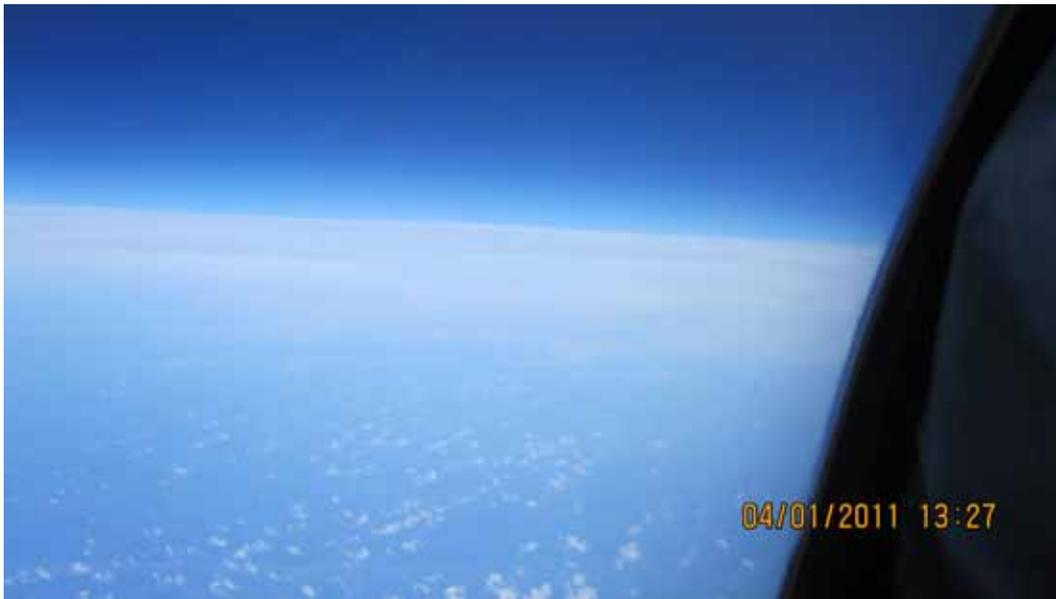
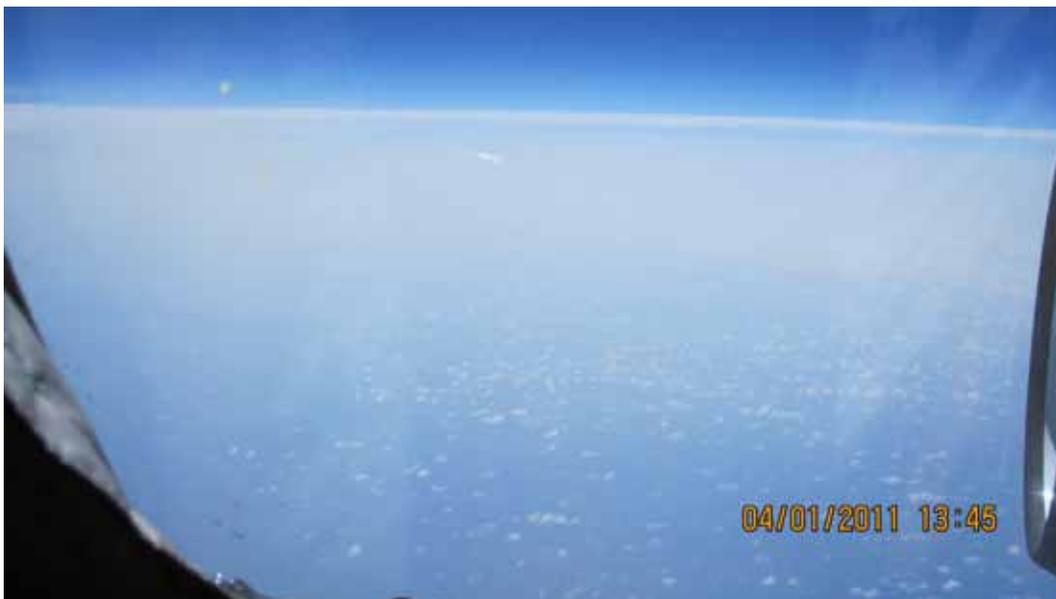
Figure 2. Images of cirrus over cumulus taken from WB57. Timestamp on image is MDT. Top image captured at 1927 UTC. Bottom image captured at 1945 UTC.
